Abandoned Uranium Mine Site Assessment for the Varnum Site (NM0116)

FINAL REPORT

NM0116

INTERA Incorporated (INTERA) has prepared this Abandoned Uranium Mine (AUM) Site Assessment Report for the Mining and Minerals Division (MMD) of the New Mexico Energy, Minerals and Natural Resources Department (EMNRD) in compliance with the Professional Service Agreement dated November 2, 2009. INTERA visited the Varnum Site (AUM Site), MMD ID: NM0116, on February 26, 2010.

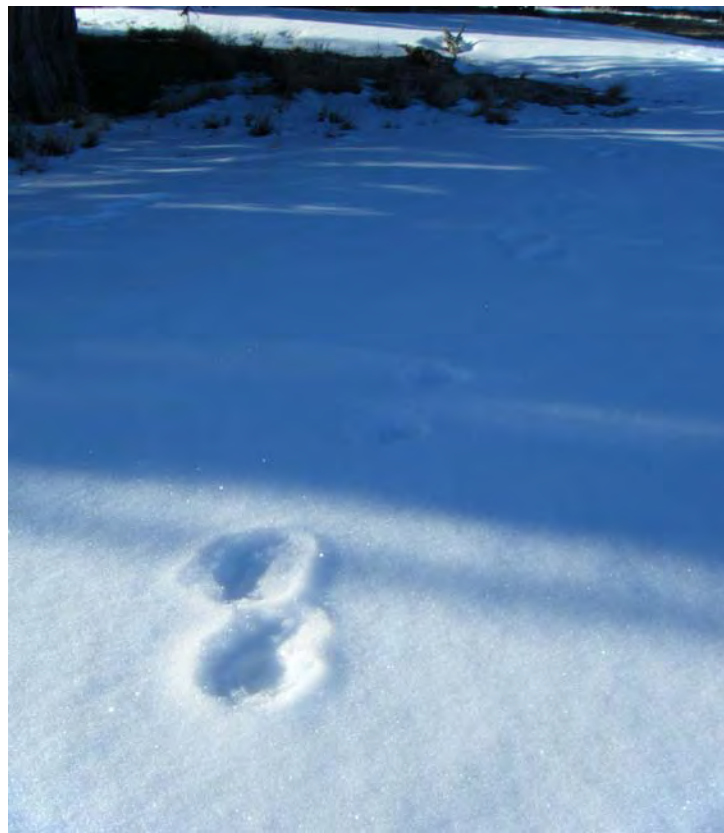
Deer or elk tracks were noted in the snow (see Photo 2 in Appendix A). Possible rodent nests were also observed.

Photo 2-Animal tracks at the AUM Site.

Photo 2 - animal tracks, probably deer

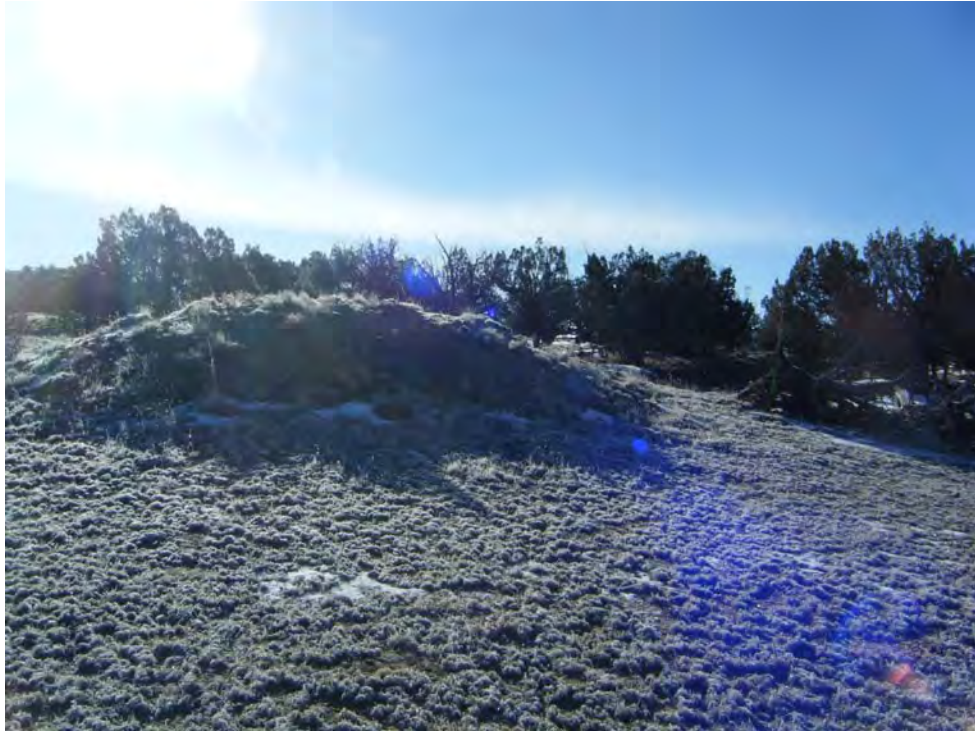
Two piles were discovered at the AUM Site. One pile (PilePly-1) probably represents material excavated from Cut-1. PilePly-1 consists of mostly soil with scattered rocks about a foot in diameter. The other pile (PilePly-2) is a low mound of broken rocks. Neither pile showed gamma readings above background for the Site.

Photo 3-Looking southeast at PilePly-1.

Photo 3 - pile 1, cut 1 is in background,
looking SE

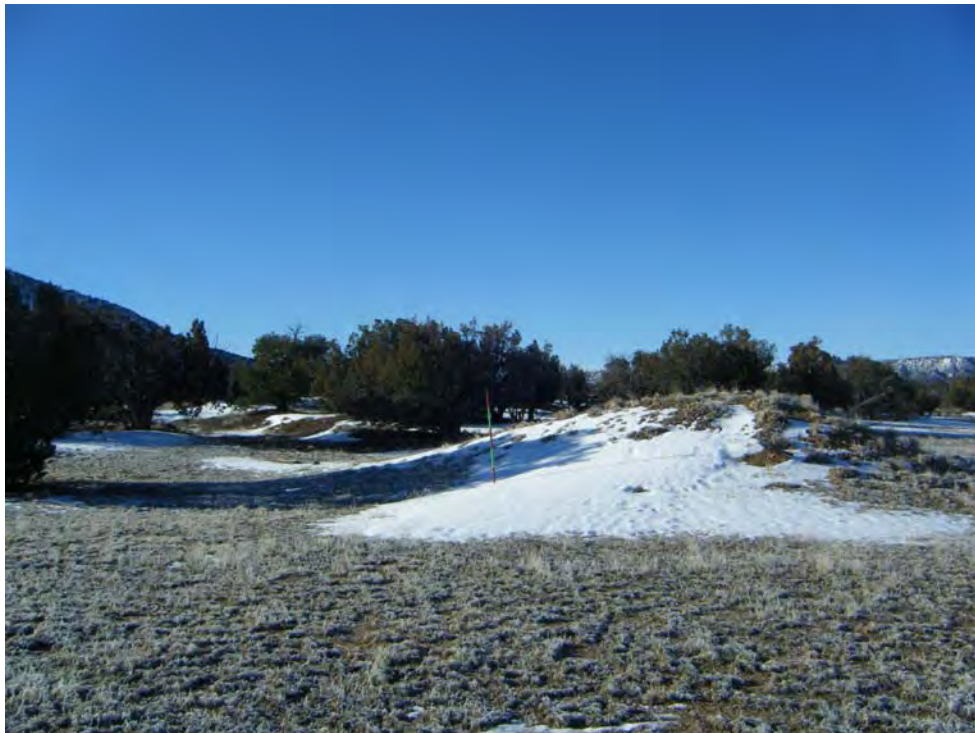
Photo 4-Looking southwest at PilePly-1 (foreground) and Cut-1 (background).

Photo 4 - pile 1, cut 1 in background,
looking SW

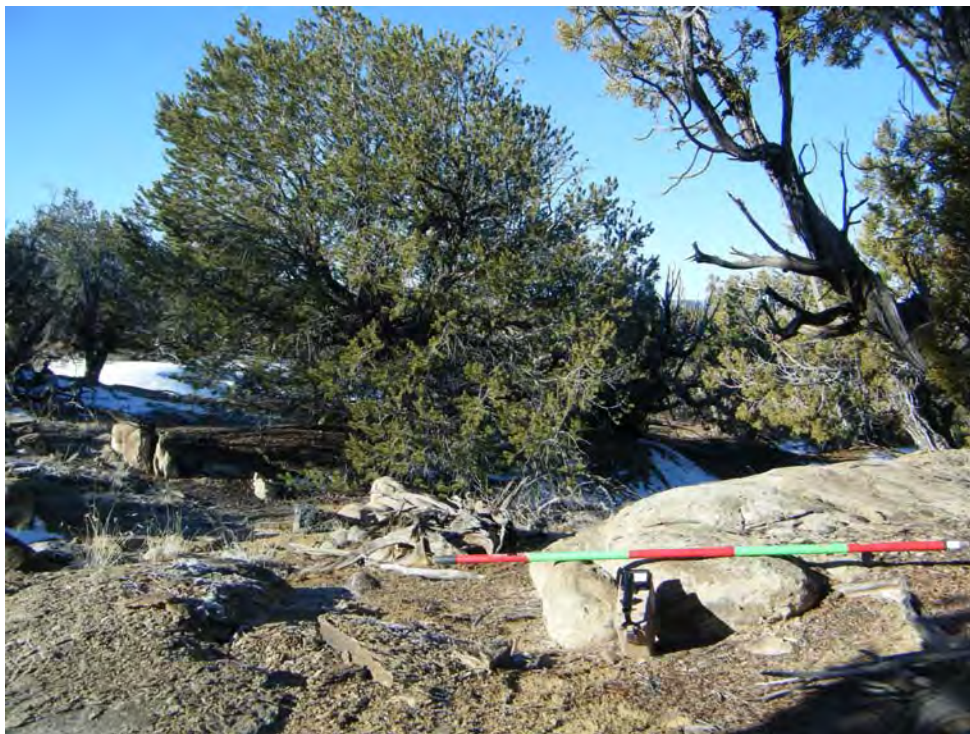
Photo 5-Looking southwest at point Rad-3.

Photo 5 - rad 3, looking SW

Rad 3 - contact = 14 μ R/hr; 1m = 11 μ R/hr

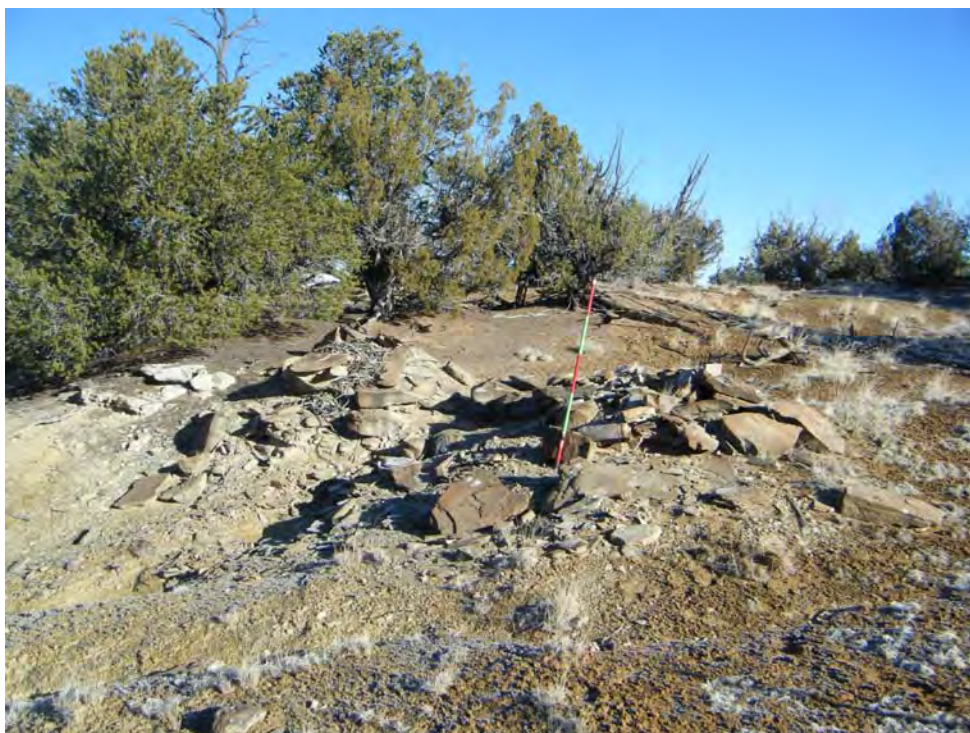
Photo 6-Looking north at PilePly-2.

Photo 6 - pile 2, looking N

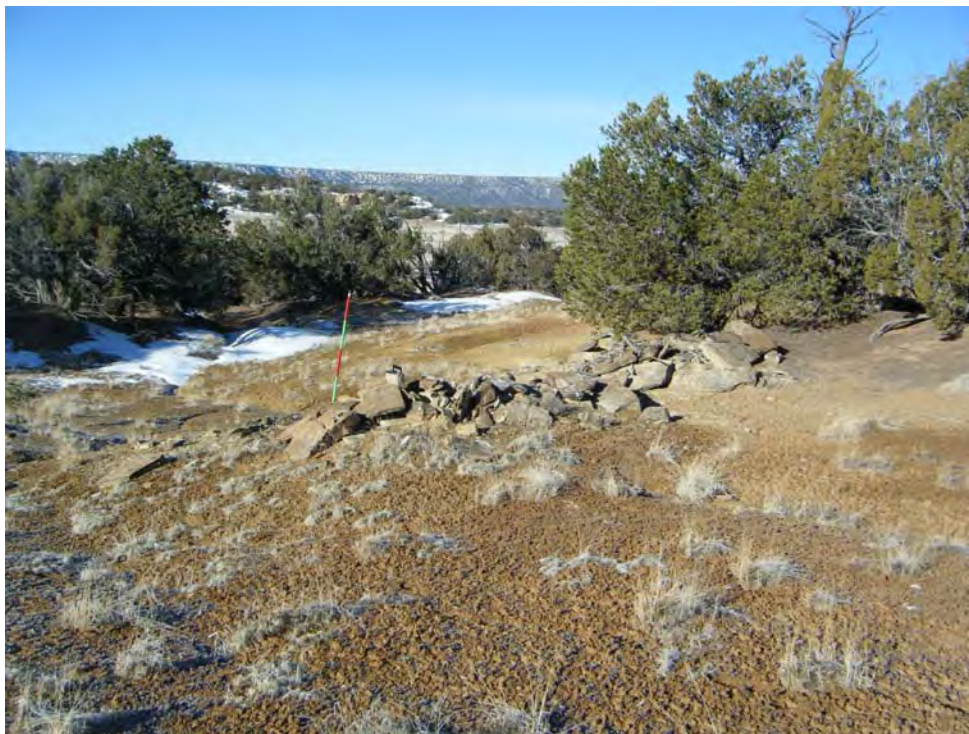
Photo 7-Looking west at PilePly-2.

Photo 7 - pile 2, looking W

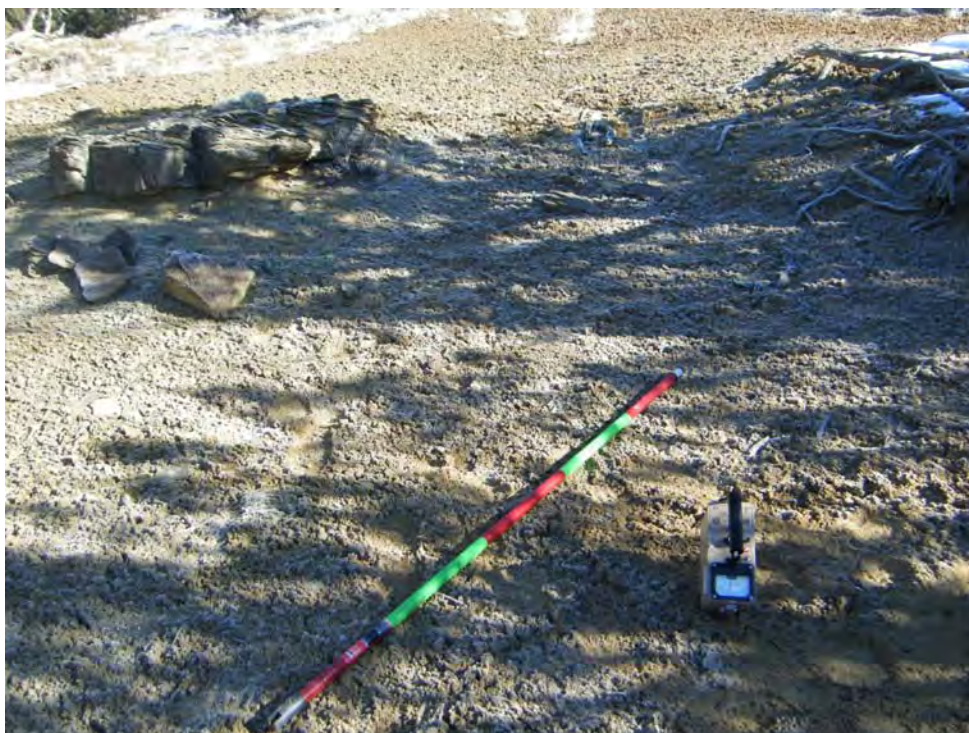
The maximum gamma radiation reading for the AUM Site was 100 $\mu\text{R/hr}$ at contact at point Rad-8. This reading was recorded on a soil-covered hillside (see Photo 13). Adjacent bedrock was not radioactive. One other location (point Rad-5) recorded 30 $\mu\text{R/hr}$ at contact, approximately 3 times background level. Like point Rad-8, this location was covered with soil; nearby rocks were not radioactive.

Photo 11-Photo of point Rad-5. Scintillometer marks the point of highest gamma readings.

Photo 11 - Rad 5, anomalous high reading, no
mine features nearby, rock in upper left
of photo is not rad source

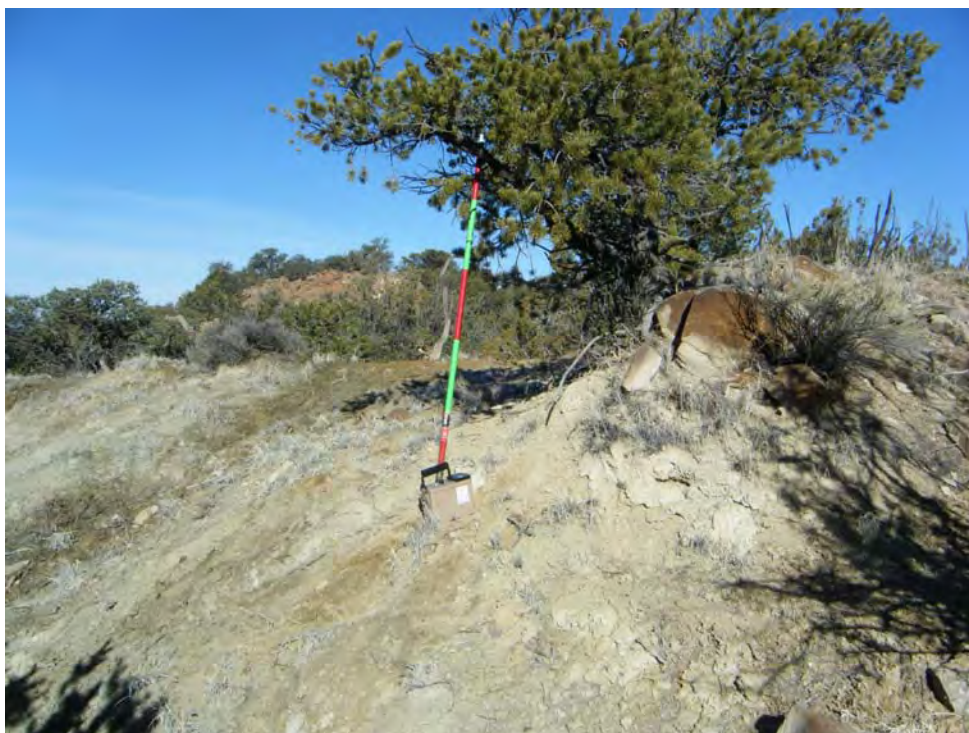
Photo 13-Looking west at point Rad-8. Scintillometer indicates area of highest gamma ray readings.

Rad 8 - contact = $100 \mu\text{R/hr}$; $1\text{m} = 27 \mu\text{R/hr}$
